STONE DURABILITY UNDER CLIMATIC INFLUENCES: A CASE STUDY OF THE YUGOSLAV MONUMENT AT THE MAUTHAUSEN MEMORIAL

Republic Institute for the Protection of Cultural Monuments of Serbia
Belgrade

First Stećci Conference: Preserving Cultural Heritage in Times of Climate Change
25–27 September 2025
University of Applied Arts Vienna

In 2024, based on research concerning the existing condition of the monument, the Institute for the Protection of Cultural Monuments of Serbia prepared a **Project for Conservation and Restoration Works with a Proposal for Structural Rehabilitation of the Yugoslav Monument at the Mauthausen Memorial in the Republic of Austria**.

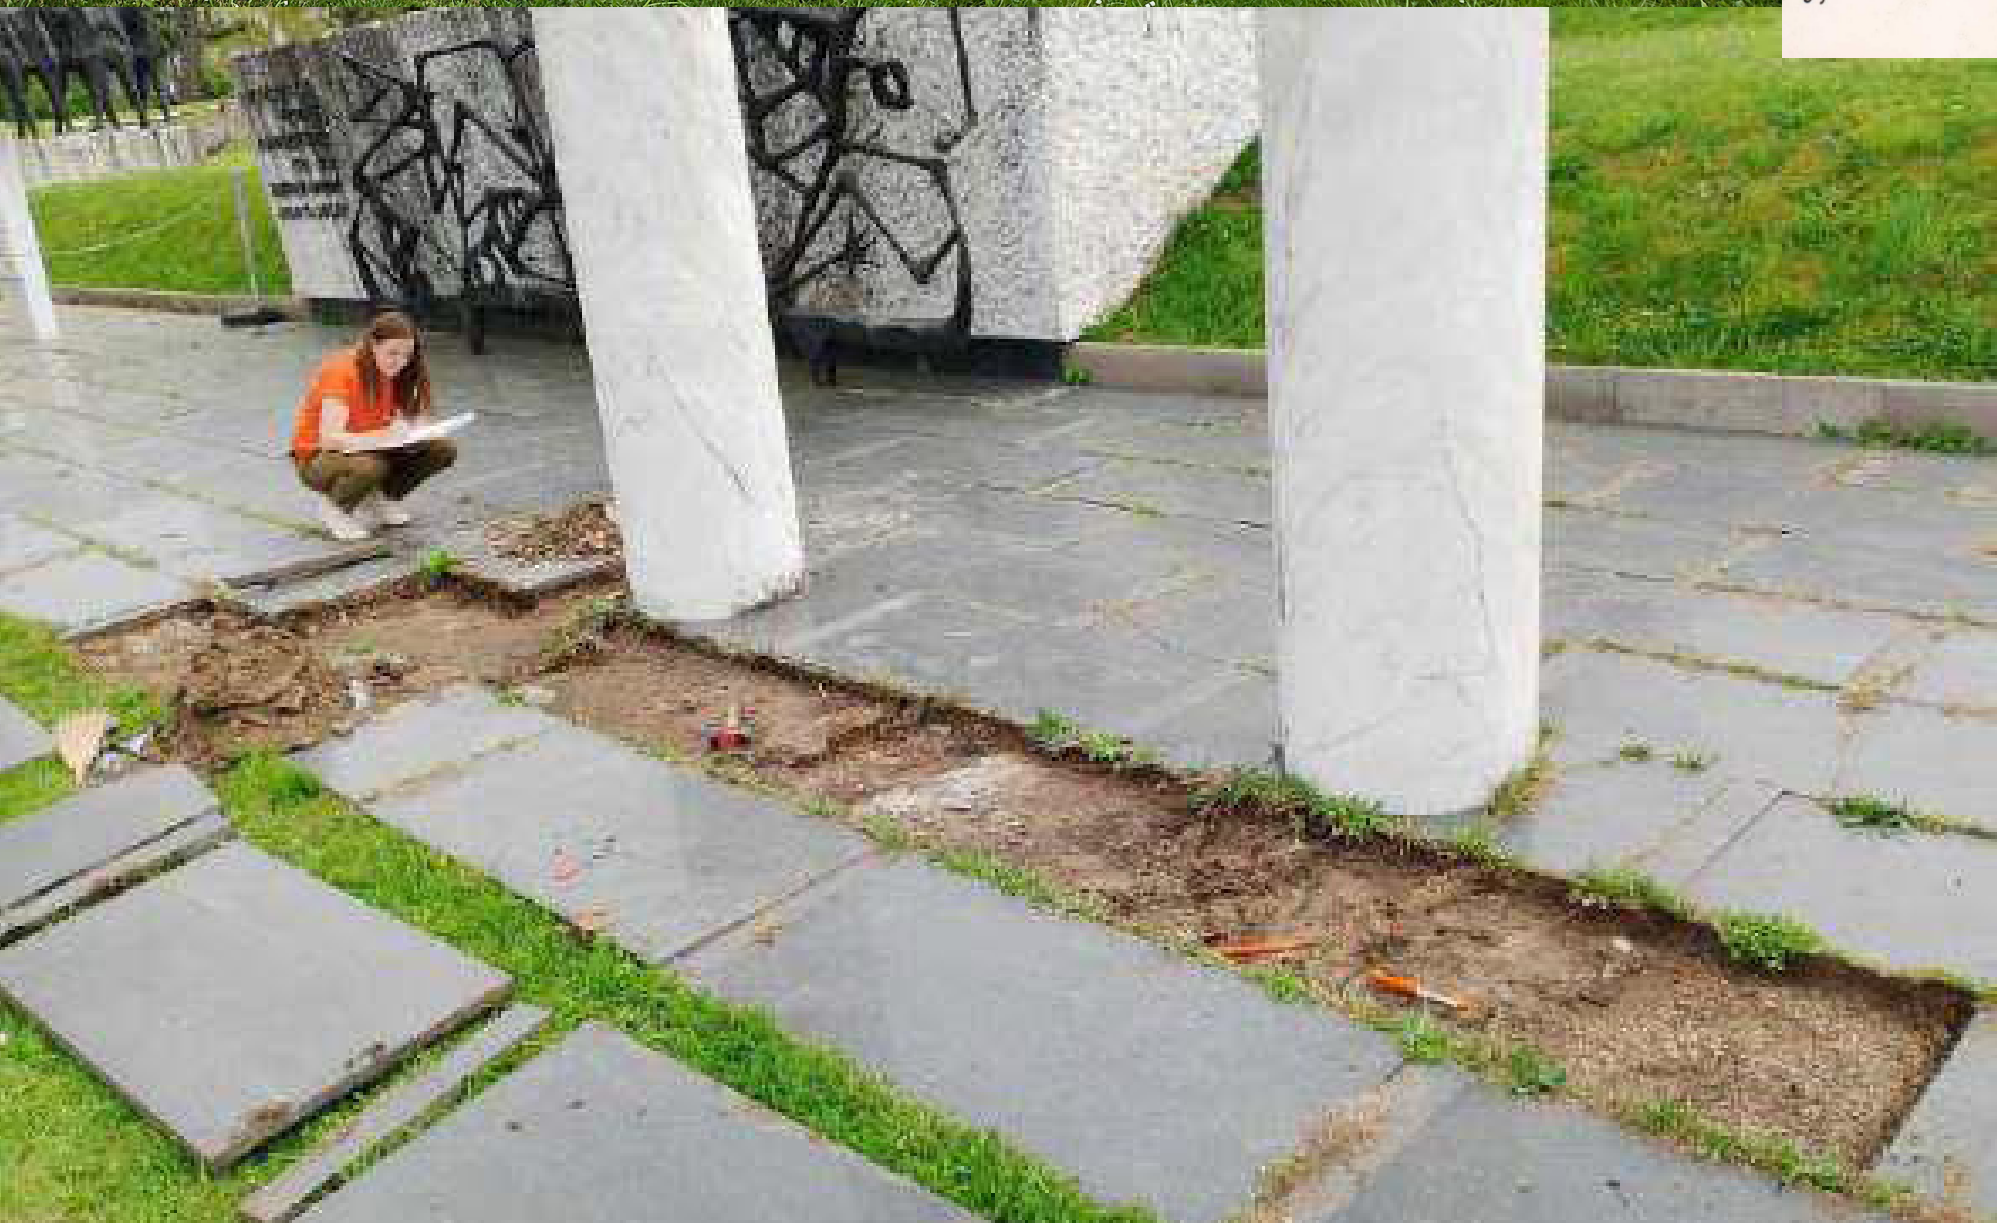
Visual inspection and detailed documentation confirmed that the marble columns are tilted. However, no archival geodetic survey exists to identify the cause of this deformation. On-site tests of material strength showed that the right column has a compressive strength of 44–48 MPa, while the left measures 46–48 (52) MPa. Cracks were recorded in the lower zones of both columns.
