STONE MONUMENT ENSEMBLES AND THE CLIMATE CHANGE IMPACT

COMPLETION OF THE CONDITION ASSESSMENT
OF THE REFERENCE SITES

Project acronym:	STECCI
Project full title:	STone monument Ensembles and the Climate Change Impact
Programme:	European Commission, Horizon Europe
Project ID:	101094822
Date:	09/2024
Authors:	Marija Milchin, Farkas Pintér, Katharina Fuchs, Abdelrhman Fahmy
Contributing authors:	Siniša Bizjak, Miona Miliša, Krešimir Bosnić, Vincent Thiéry, Samir Đug
Reviewer	Stefan Simon, Saida Ibragić

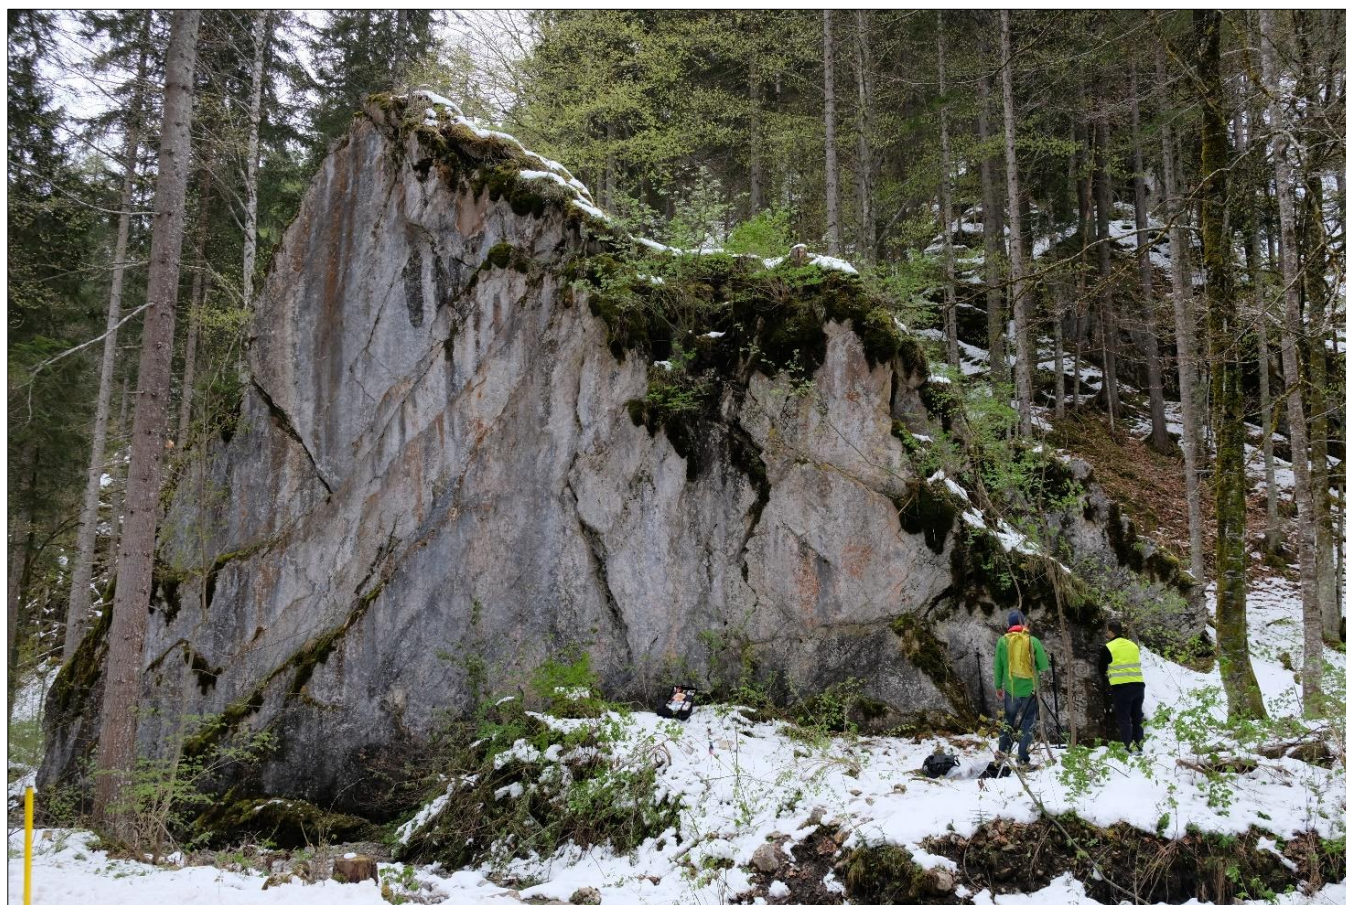
The “Hundskirche” (Fig. 2) is a rock formation near Paternion, Carinthia, Austria, featuring historically significant carvings (Fig. 3) that reflect the spread of early Protestantism in Austria during the 16th century. The monument is connected to the bedrock and composed of compact dolomitic limestone.

Fig. 2: Overview, “Hundskirche”

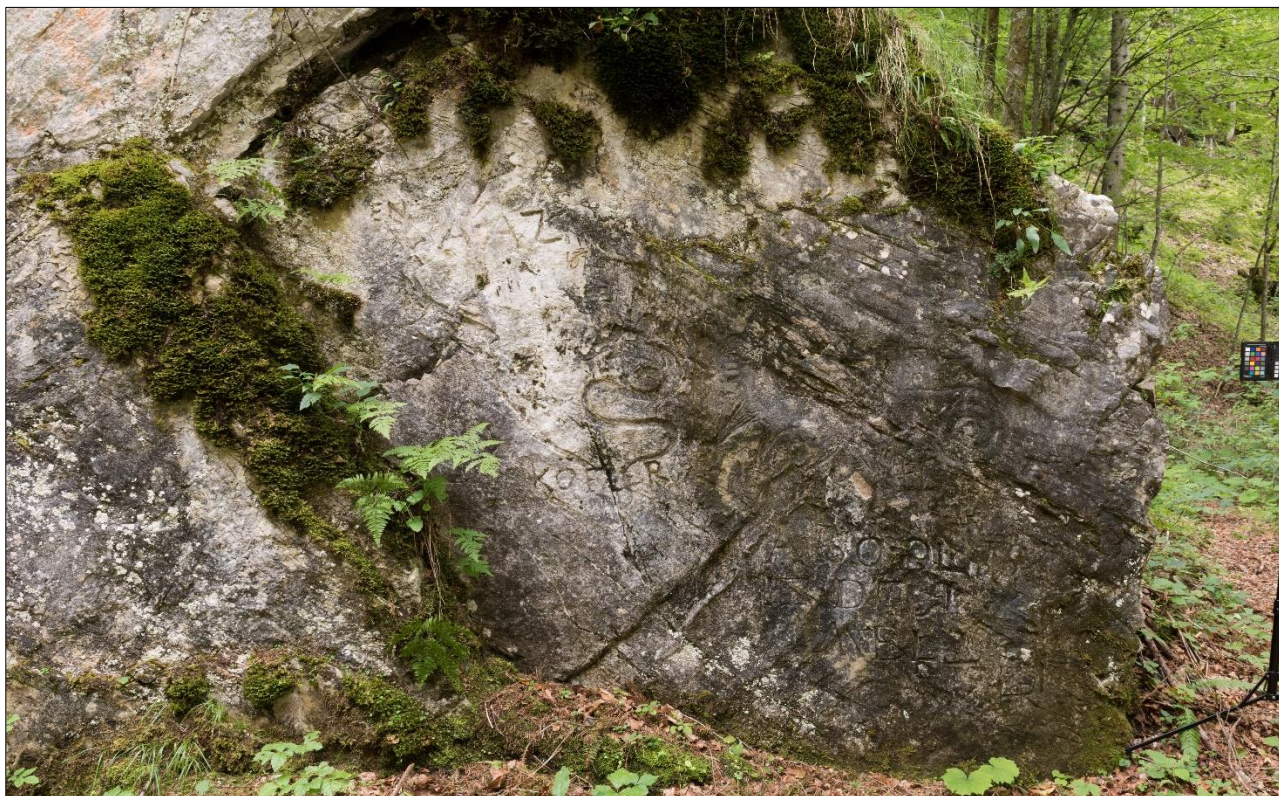
Fig. 3: The carvings on the right-hand site of the rock formation

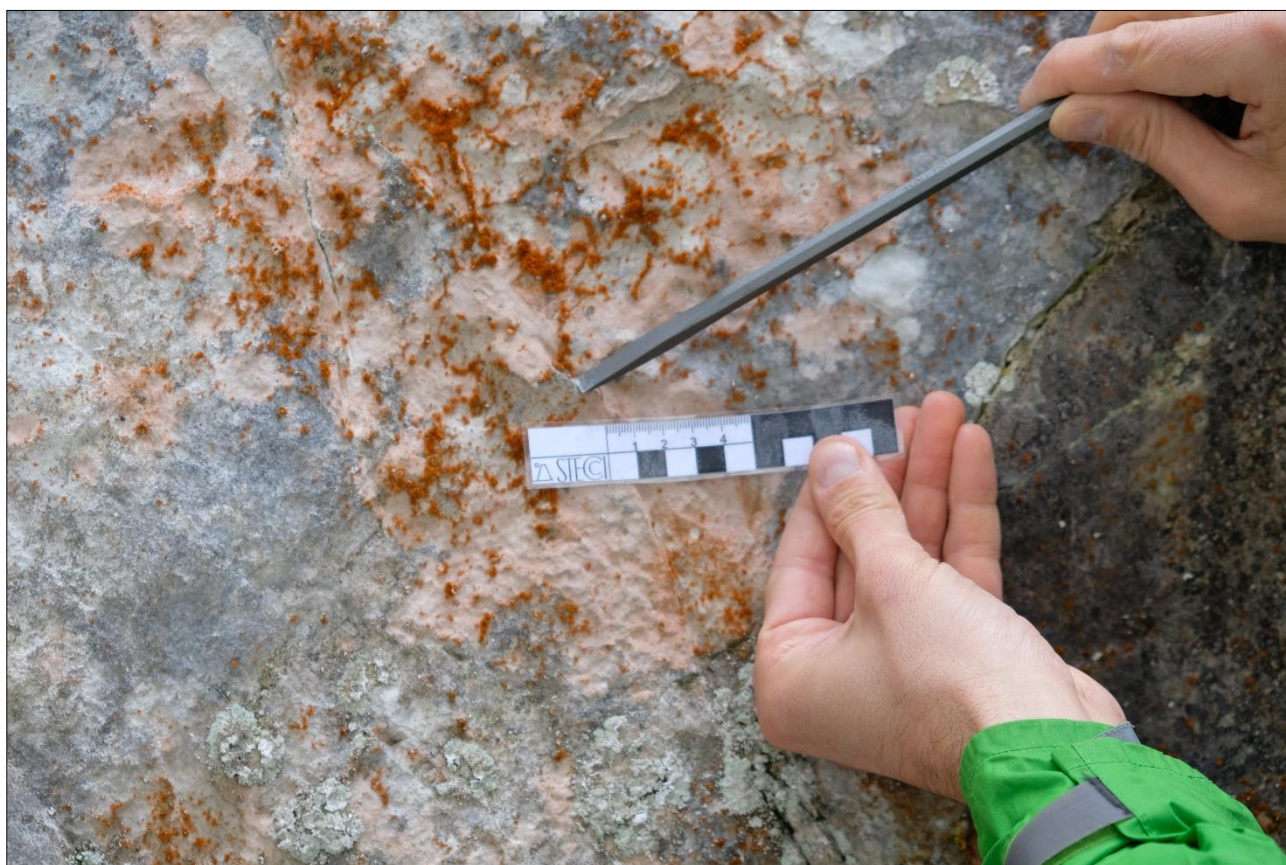
Despite Carinthia's alpine character greeting the team with a 15 cm snow cover, the condition assessment was successfully completed. It quickly became clear that the primary damage risks at this site stem from freeze-thaw cycles, combined with inherent microcracking in the material and significant biological colonization (Fig. 4).

Fig. 4: Some of the lichens present on the surface of “Hundskirche”

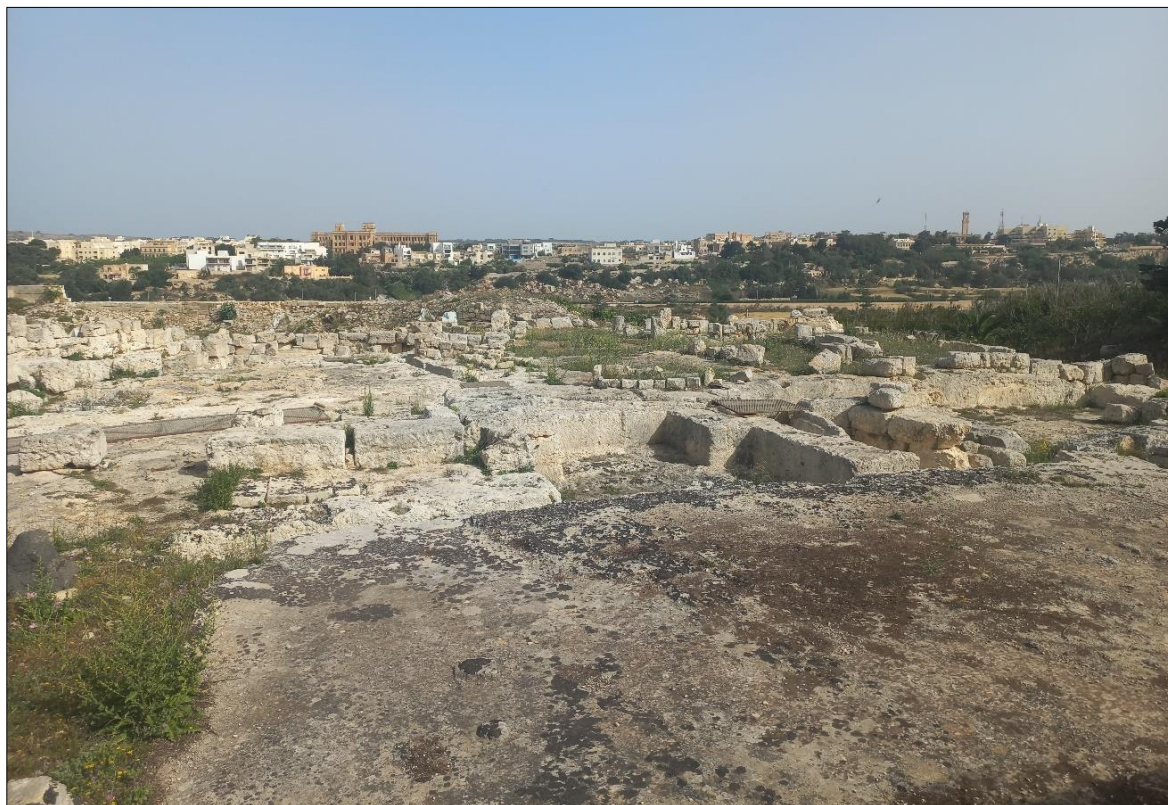
This was the second of four condition assessments planned as part of Task 3.1 of the STECCI project. The site, “Domvs Romana” in Rabat, Malta (Fig. 5), consists of archaeological remains of a rich residential building from the Roman period (built in the 1st century BC) and a later layer from the 11th century AD consisting of Muslim graves; the site was reused as a cemetery during the time of the Fatimid Caliphate. The monuments are made of a highly porous local limestone, most of which are identified as different qualities of Globigerina limestone.

Fig. 5: Overview, “Domvs Romana”

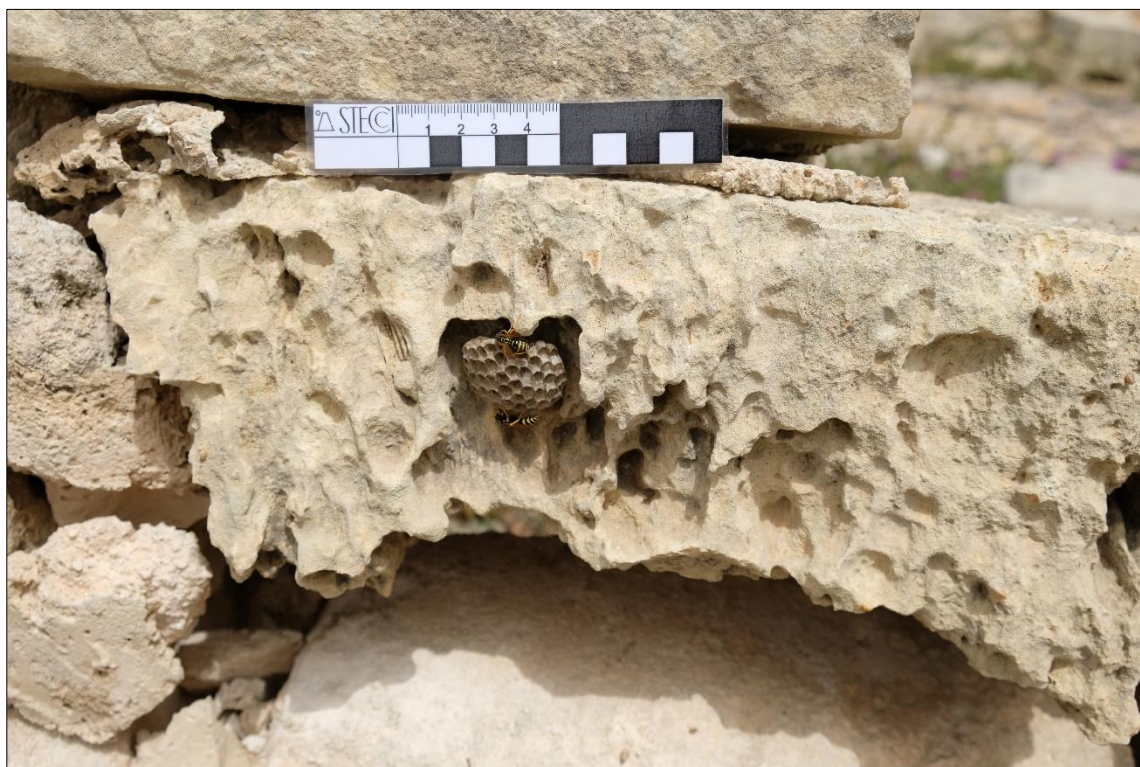
Some initial conclusions were drawn shortly after the on-site work. The proximity to the sea, combined with wind and heat, appear to be the most significant causes of decay, particularly when interacting with the properties of the stone material used.

Fig. 7: Typical, “honeycomb” decay pattern is the result of the action of wind and salts on (mostly) porous limestones

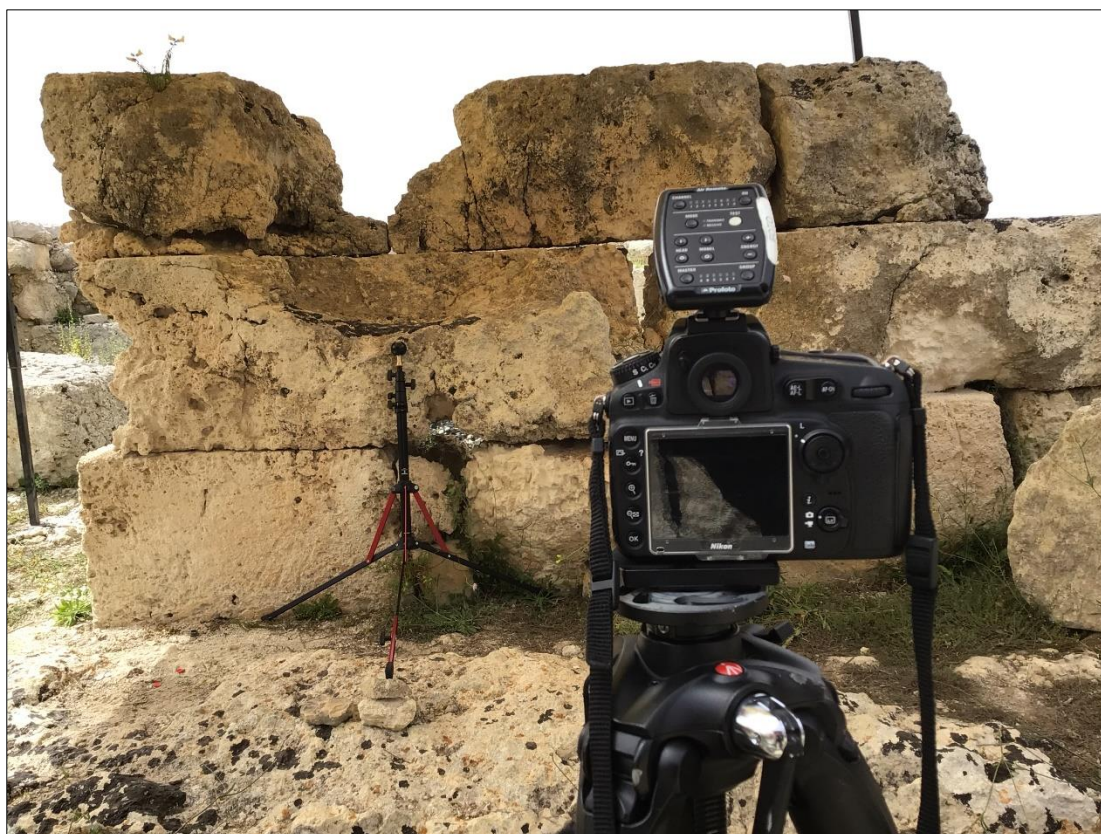
The condition assessment included visual inspection and a range of *in-situ* tests, such as contact sponge and Karsten tube tests, the so-called brush test, gloss and color measurements, ultrasonic velocity, etc. Digital mapping of decay and damage patterns as well as RTI photography (Fig. 8) were used to visually capture the situation. For the bioassessment, which was conducted as part of the condition assessment microbial biofilm samples were collected for lab analyses. Sampling was performed according to the standard guidelines (UNI EN Standard, 2012). The samples were protected from contamination, mechanical damage, and alternation during transportation to storage. Each sample was identified with the sample identification code and stored until analysis.

Fig. 8: The setup for RTI photography

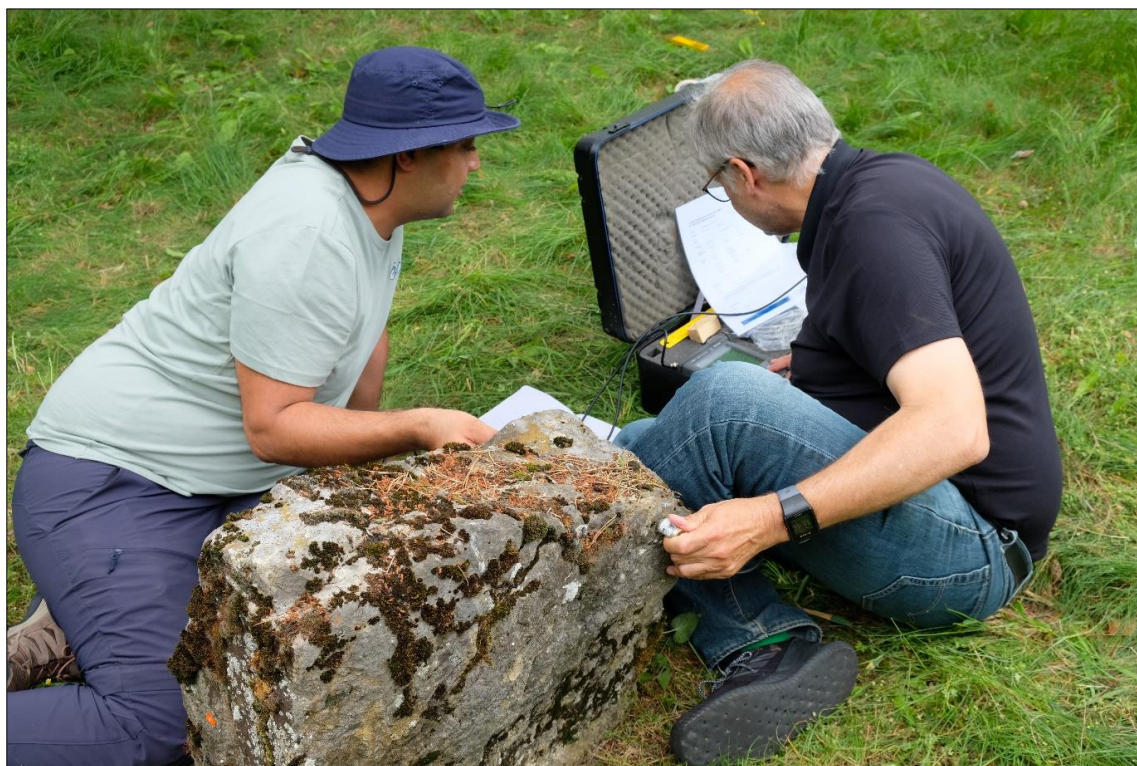
The condition assessment included visual inspection and a range of *in-situ* tests, such as contact sponge and Karsten tube tests for water absorption, brush test for surface material loss (Fig. 11), gloss and color measurements, ultrasonic velocity (see Fig. 9), etc. Digital mapping of decay and damage patterns, as well as RTI photography, were used to visually capture the situation on-site.

Fig. 9: The SPK team conducting Ultrasonic measurements at the Jewish cemetery in Kleinbardorf

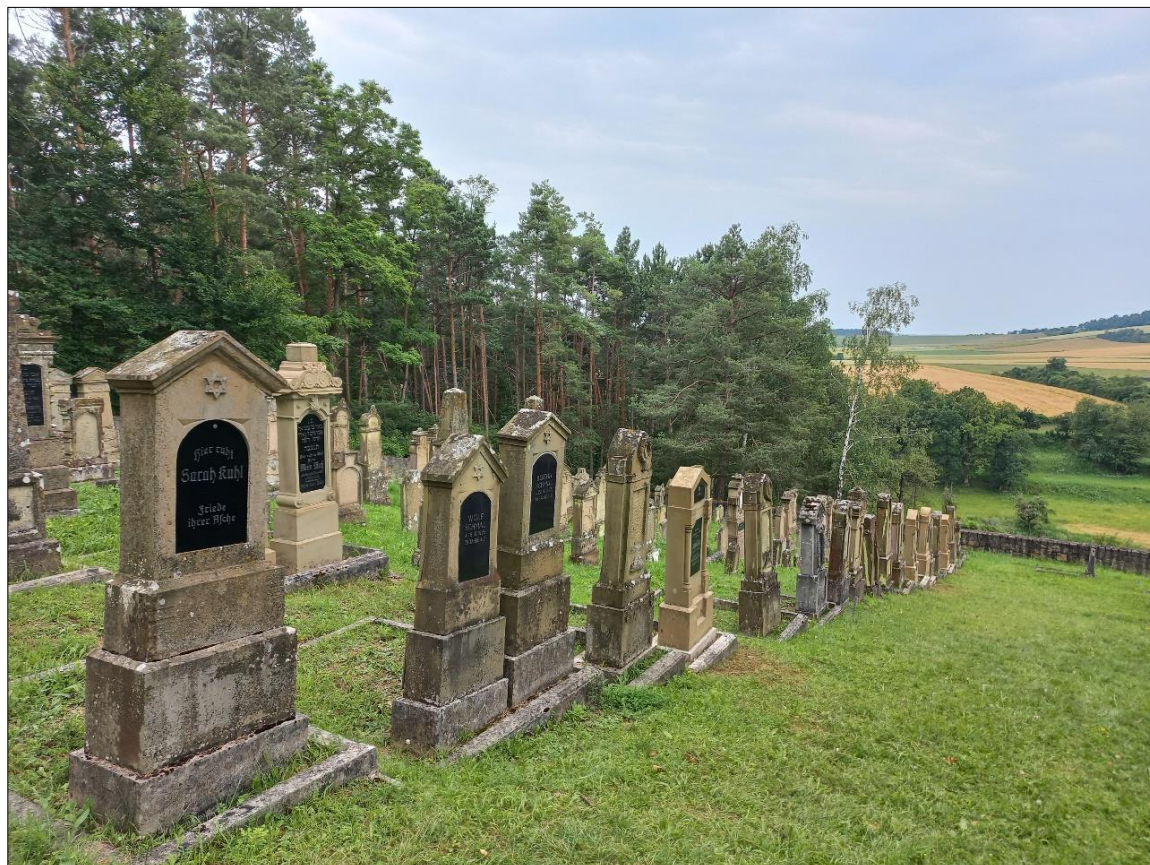
The cemetery in Kleinbardorf contains of around 3,500 graves and gravestones, some dating back to the 16th century; the last funeral dated to 1938. The cemetery in Unsleben is much smaller and also presents a more compact history of use, with most of the graves originating from the 19th century. The predominant stone used was a local siliceous sandstone, however, a few limestone and marble objects were also identified and used for the detailed condition assessment for the STECCI Project.

Fig. 10: The Jewish cemetery in Unsleben, overview

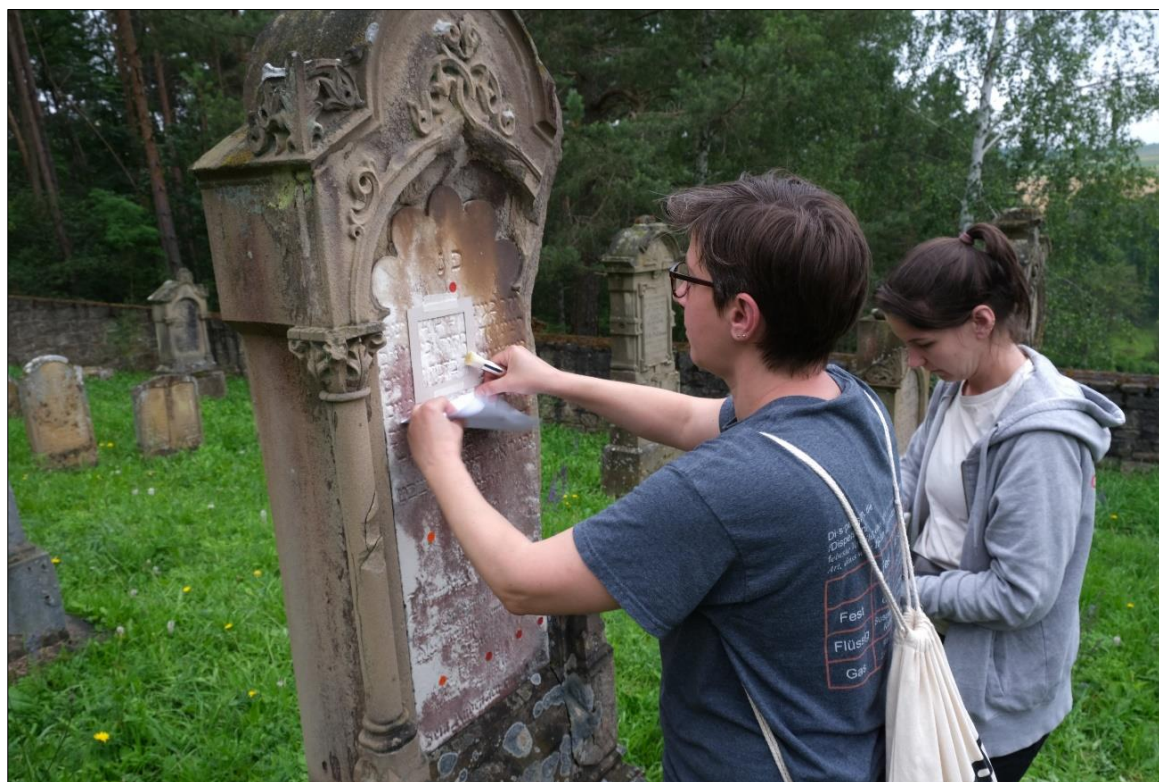
Fig. 11: Implementation of the “Brush test” for the evaluation of the superficial material loss and decohesion

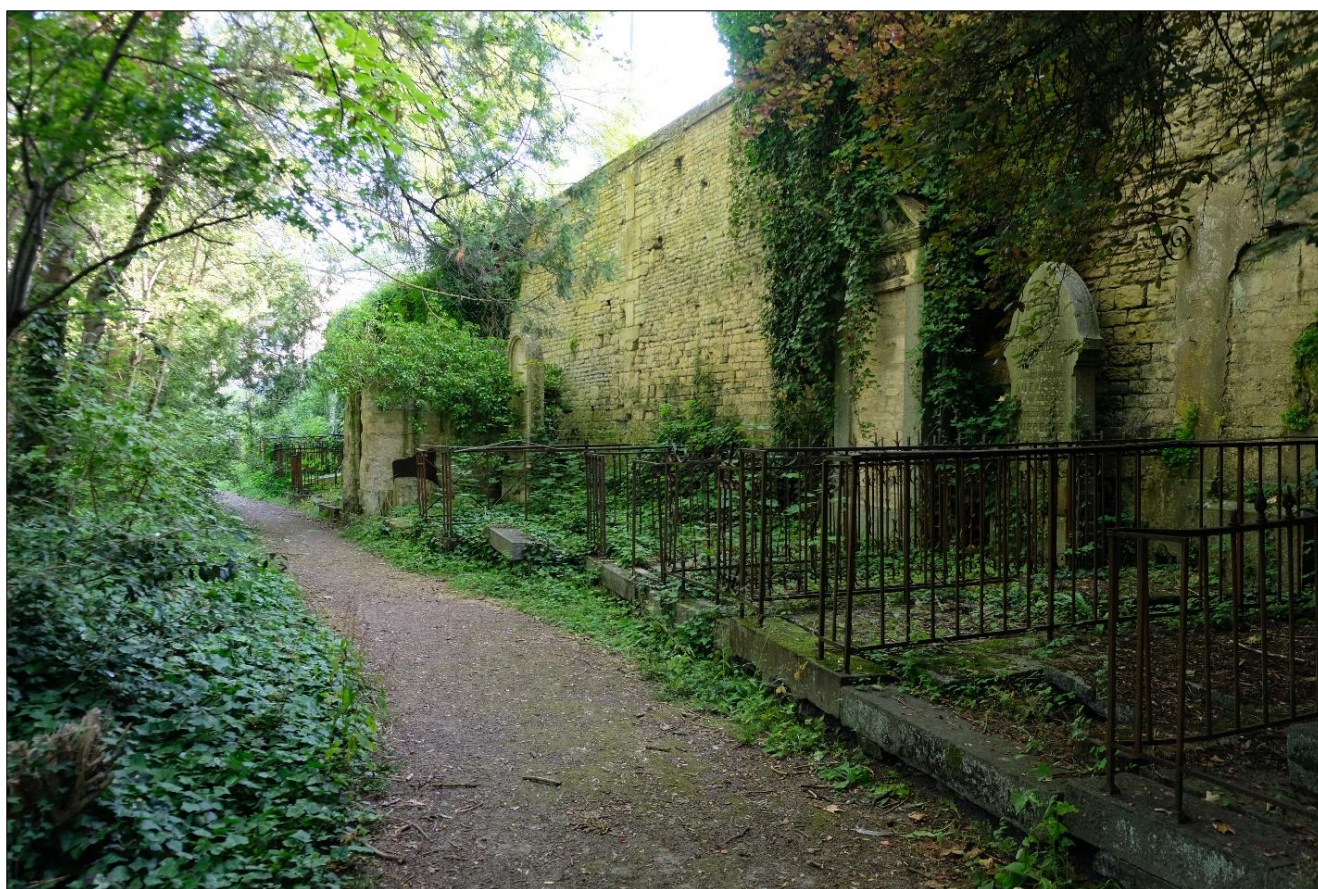
The Cimetière Saint Jean is a small historical cemetery featuring a few dozen 19th-century graves and crypts, primarily made of porous Caen stone (Fig.12). Now converted into a park in the city center, it has suffered a century of neglect, leading to the poor preservation of most graves. The combination of proximity to the sea, neglect, the high porosity of the stone, and the surrounding natural environment has resulted in decay mechanisms largely driven by salt, wind, and biological colonization.

Fig. 12. The Cimetière Saint Jean, an overview

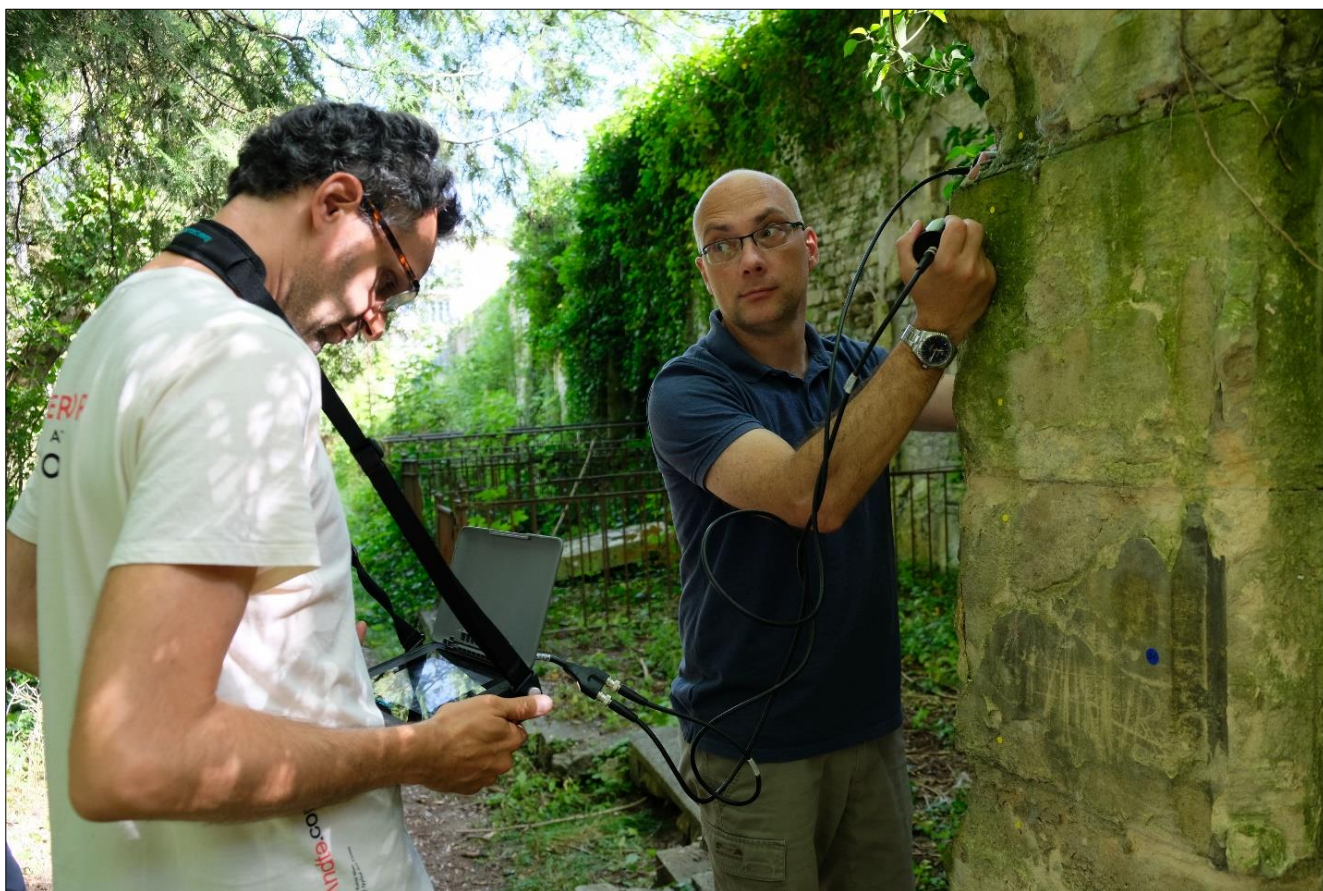
The assessment focused on two objects - a small crypt and a gravestone - both made of Caen stone. The team carried out visual inspections and various *in-situ* tests, including contact sponge, Karsten tube, brush test, gloss and color measurements, and ultrasonic velocity testing (Fig. 13). Digital mapping and RTI photography were used to document the on-site conditions.

Fig. 13: Farkas Pintér (UAA) and Vincent Thiéry (IMT) conducting ultrasonic measurements on one of the reference monuments
